Color Painter™ V-64s

# ***Troubleshooting Guide***

When you encounter “white lines”, “bleeding”, “stain” and  
“dark lines” on the print...

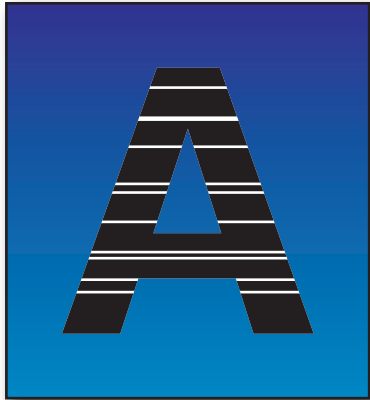
## White lines pattern 2

### Cause

- Clogged nozzles

Follow the procedures below.

Check that there is no dust on the platen, if any, remove it.

Perform the daily maintenance and confirm that the symptom is improved. (

Perform the Print head cleaning [NORMAL ALL]. Perform [NOZZLE PRINT] and confirm that the symptom is improved.

Select [RESEAT PRINthead] on the operation panel and move the carriage. After cleaning the print head nozzle surface, perform [NOZZLE PRINT] and confirm that the symptom is improved.
